NRL HYBRID RELIABILITY

PHYSICS OF FAILURE INITIAL STUDY

FINAL REPORT FOR
PERIOD 1 OCTOBER 1986 TO 30 SEPTEMBER 1988

NRL HYBRID RELIABILITY PHYSICS OF FAILURE INITIAL STUDY

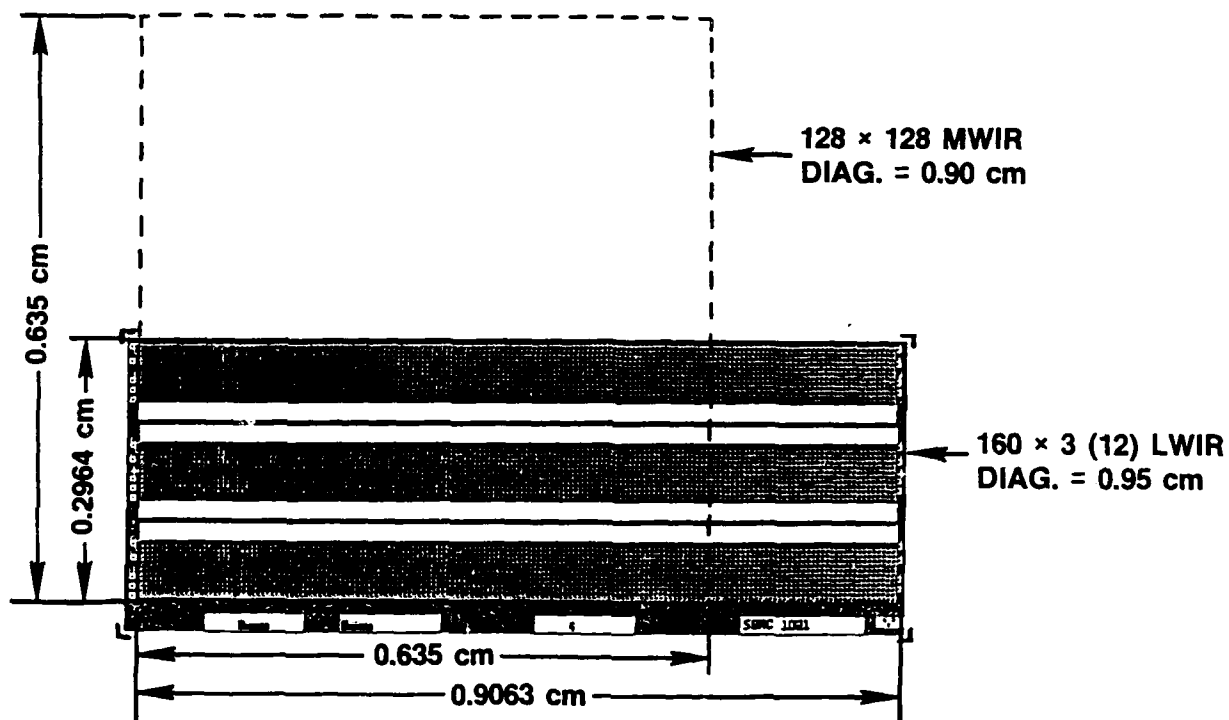
Figure 2-1. 160×3 (12) LWIR HgCdTe Array Is Structurally Similar in Length of Its Maximum Dimension (Diagonal) to 128×128 Array

The objective of this task was to obtain some initial data on the failure modes associated with PV HgCdTe hybrid arrays. As a vehicle for this testing a 160×3 (12) LWIR HgCdTe array hybridized to a Si readout was used. This hybrid is structurally similar in the length of its maximum dimension (diagonal) to a 128×128 array, as shown in Figure 2-1.

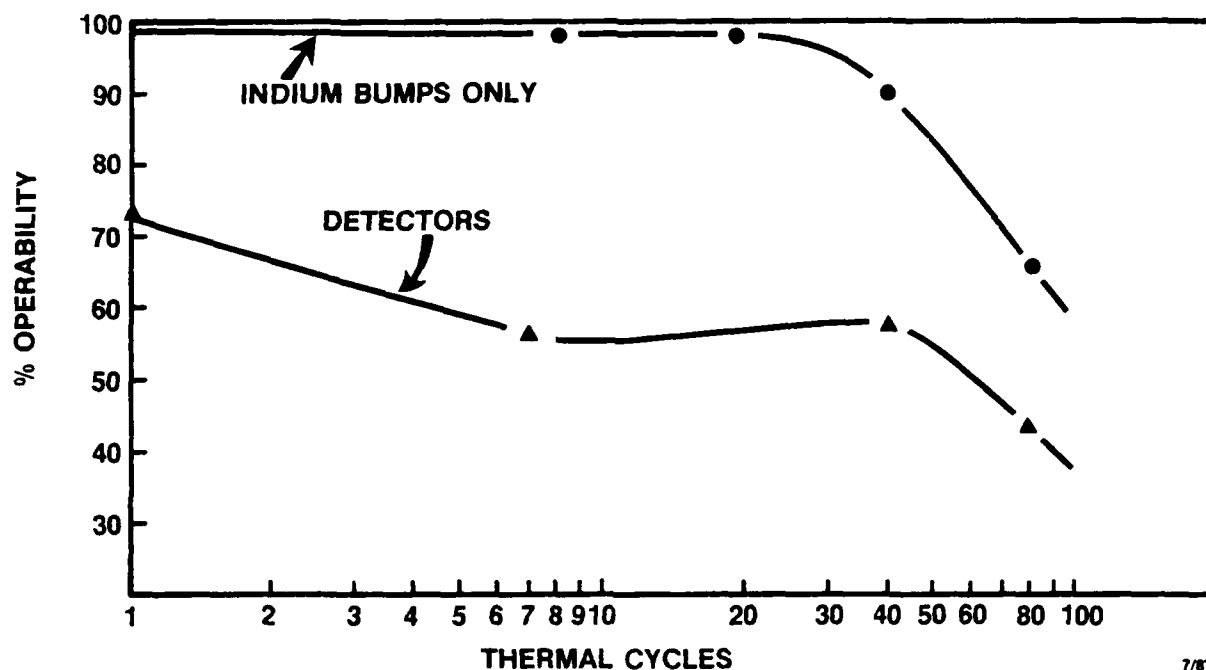
Figure 2-2 shows a plot of percent operability versus number of cumulative thermal cycles. One curve shows indium bump interconnect operability and the other curve shows detector response operability. Figure 2-2 shows that the interconnects began to fail at approximately 40 cumulative thermal cycles. Detector operability was initially 73% and degraded to 60% after 7 cycles; further degradation with thermal cycling was associated with interconnect reliability.

Figure 2-2. Percent Operability for Indium Bump Interconnects and Detector IR Response versus Cumulative Thermal Cycles (Assembly 5089)

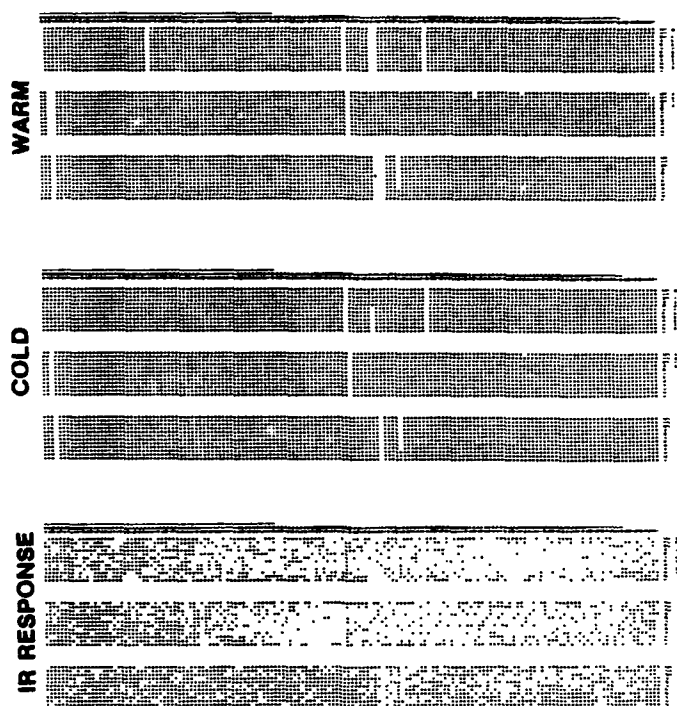
Figure 2-3. Gray-scale Map Showing Operability of Indium Bump Interconnects (Warm and Cold) and Detector IR Response after 7 Cumulative Thermal Cycles (Assembly 5089)

A more detailed look at these results is shown in Figures 2-3, 2-4, and 2-5, which show a gray scale map of indium interconnect operability at 300K and 77K and detector IR response at 77K, after 7, 40, and 81 cumulative cycles, respectively. Figure 2-3 shows that the interconnect reliability is good, but that the IR detector response operability is degraded. Figures 2-4 and 2-5 show that the indium bump interconnects are degrading with thermal cycling and the detector response is degraded only as a result of this interconnect loss. Scanning electron microscopy was used to analyze these degradation mechanisms and is discussed in the next section.

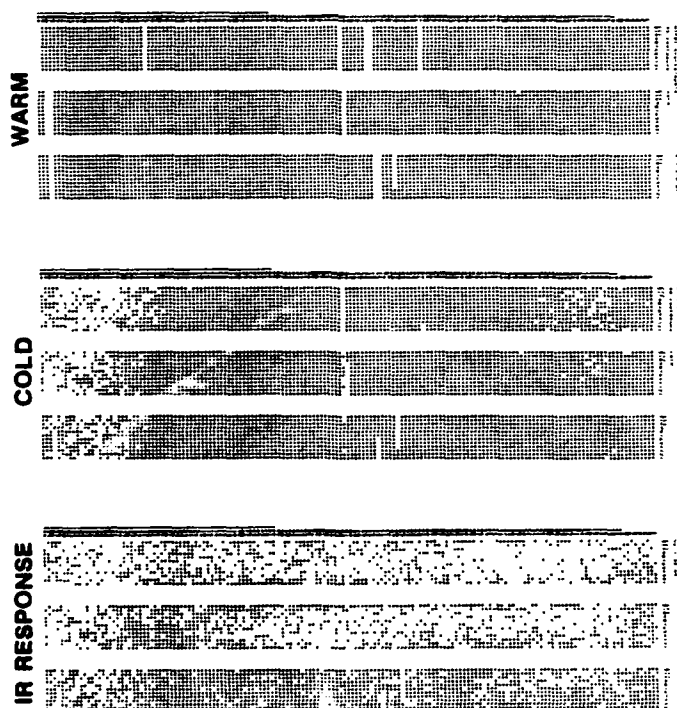
Figure 2-4. Gray-scale Map Showing Operability of Indium Bump Interconnects (Warm and Cold) and Detector IR Response after 40 Cumulative Thermal Cycles (Assembly 5089)

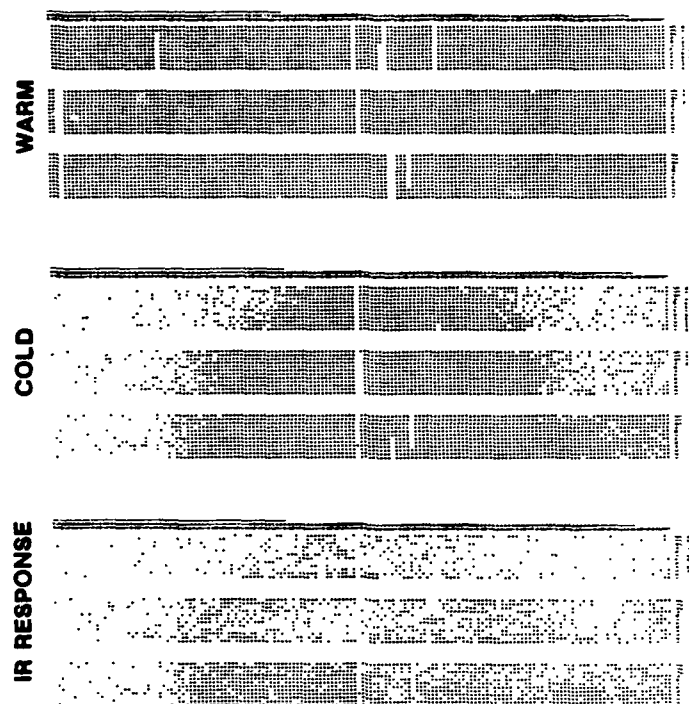
Figure 2-5. Gray-scale Map Showing Operability of Indium Bump Interconnects (Warm and Cold) and Detector IR Response after 81 Cumulative Thermal Cycles (Assembly 5089)

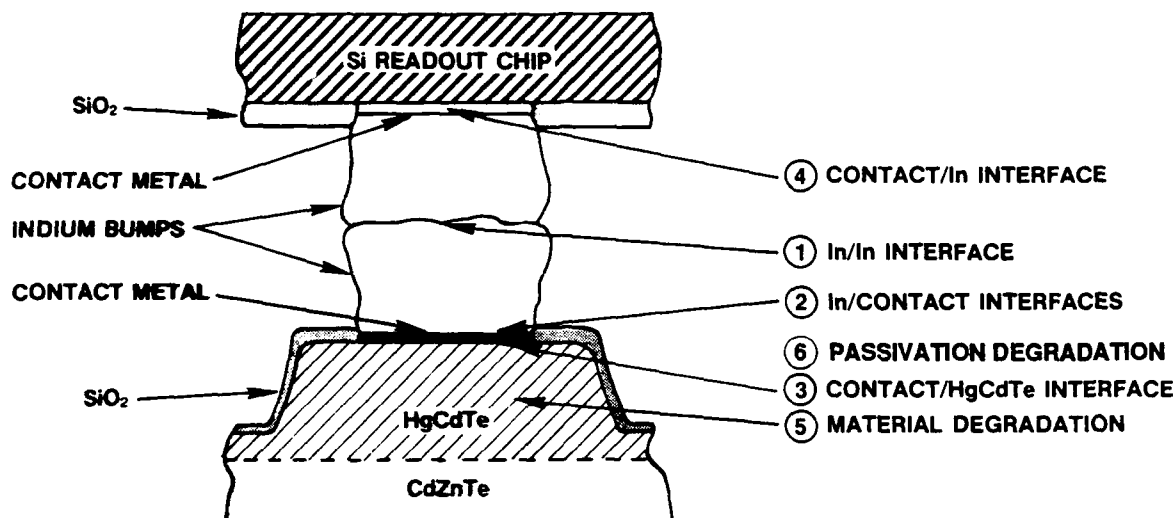
Figure 2-6 is a schematic of a cross-section of an individual pixel in a hybrid array and shows possible failure mechanisms induced by thermal cycling. The following failure mechanisms can occur:

1. HgCdTe material degradation
2. Passivation degradation

Figure 2-6. Schematic of Cross Section of Individual Pixel on Hybrid Array Showing Possible Failure Mechanisms Induced by Thermal Cycling

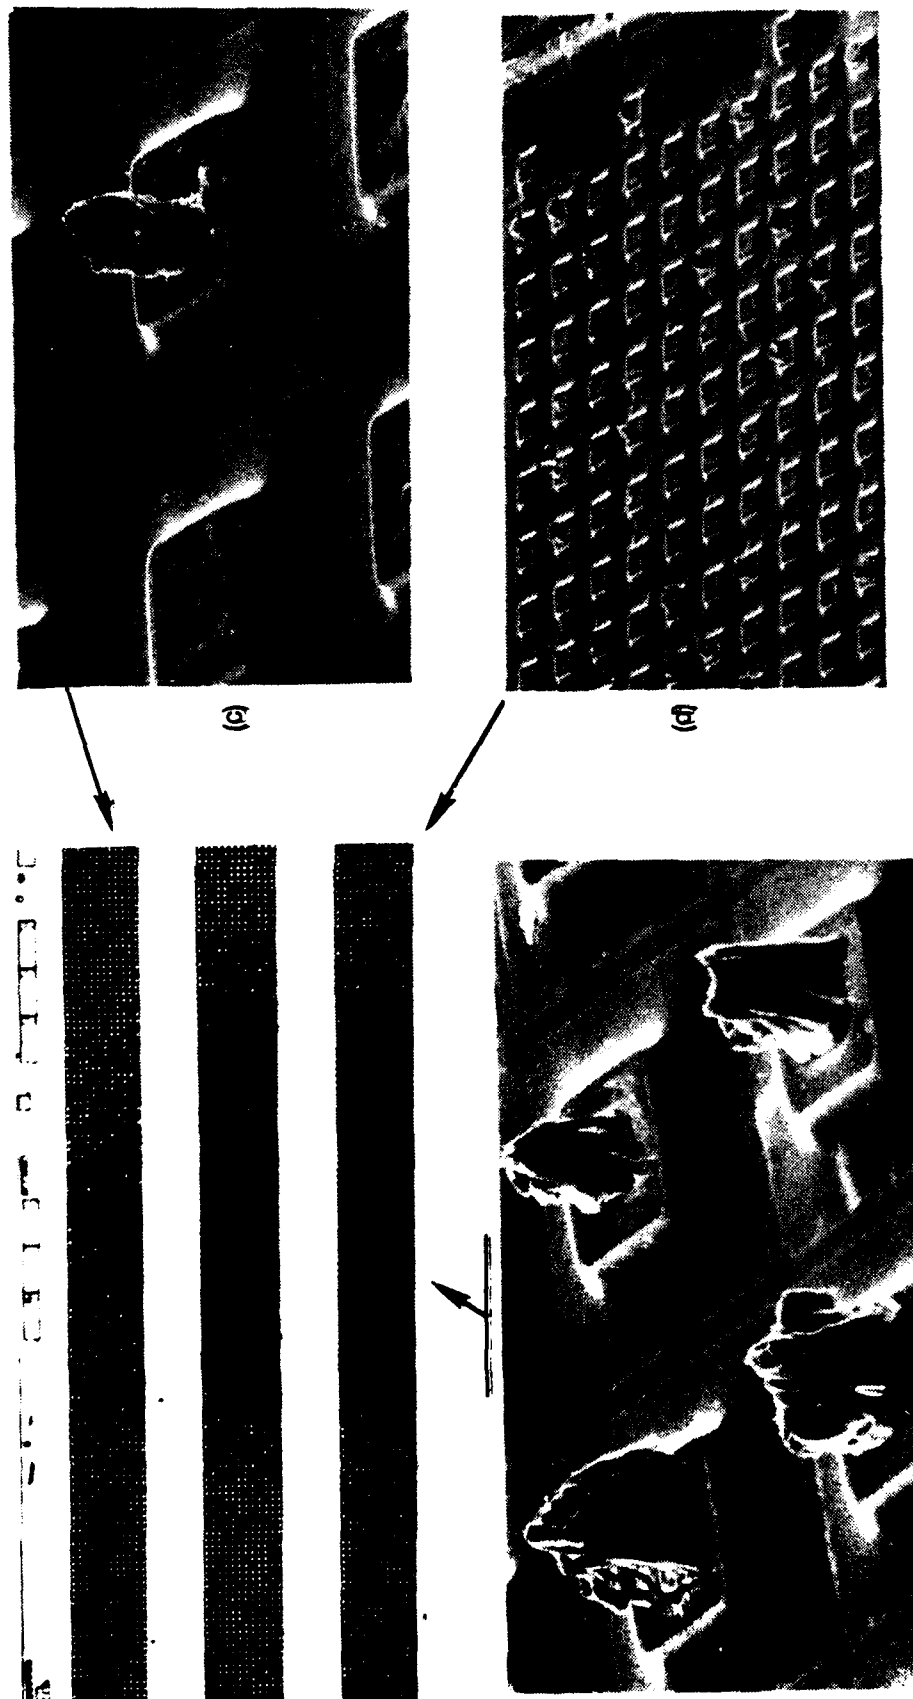
Figure 2-7a shows the gray scale map of interconnect failure of the 160×3 (12) LWIR HgCdTe hybrid array (Assembly 5089) after 81 cumulative thermal cycles; Figures 2-7b, c, and d are SEM micrographs of the array after it was pulled apart for analysis. Figure 2-7b shows an SEM micrograph of several pixels in the central region of the hybrid which showed good interconnect operability. The indium bumps showed good cold welding characteristics in this region, as evidenced by their elongated shape after pulling the array apart. Figures 2-7b and c show micrographs of pixels in the exterior region of the array which exhibited poor interconnect operability upon thermal cycling. These figures show that the dominant failure mechanism was contact delamination at the contact metal/HgCdTe interface. This was probably due to surface contamination sometime prior to the metallization step and is not an inherent process limitation.

Figure 2-7. (a) Gray-scale Map Showing Operability of Indium Bump Interconnects after 81 Cumulative Thermal Cycles (Assembly 5089). (b) SEM Micrograph of Pixels (after pulling apart hybrid) of Good Interconnects in Interior of Array Showing Good Indium Bump Cold-welding Characteristics. (c) SEM Micrograph Showing Interconnect Delamination at Contact Metal/HgCdTe Interface. (d) SEM Micrograph of Many Pixels Showing Interconnect Delamination.

These failures were apparently due to unwanted surface contamination during the processing of this device and are not inherent limitations to hybrid detector arrays. These problems have been eliminated in the process and did not affect further experiments discussed in the next sections.

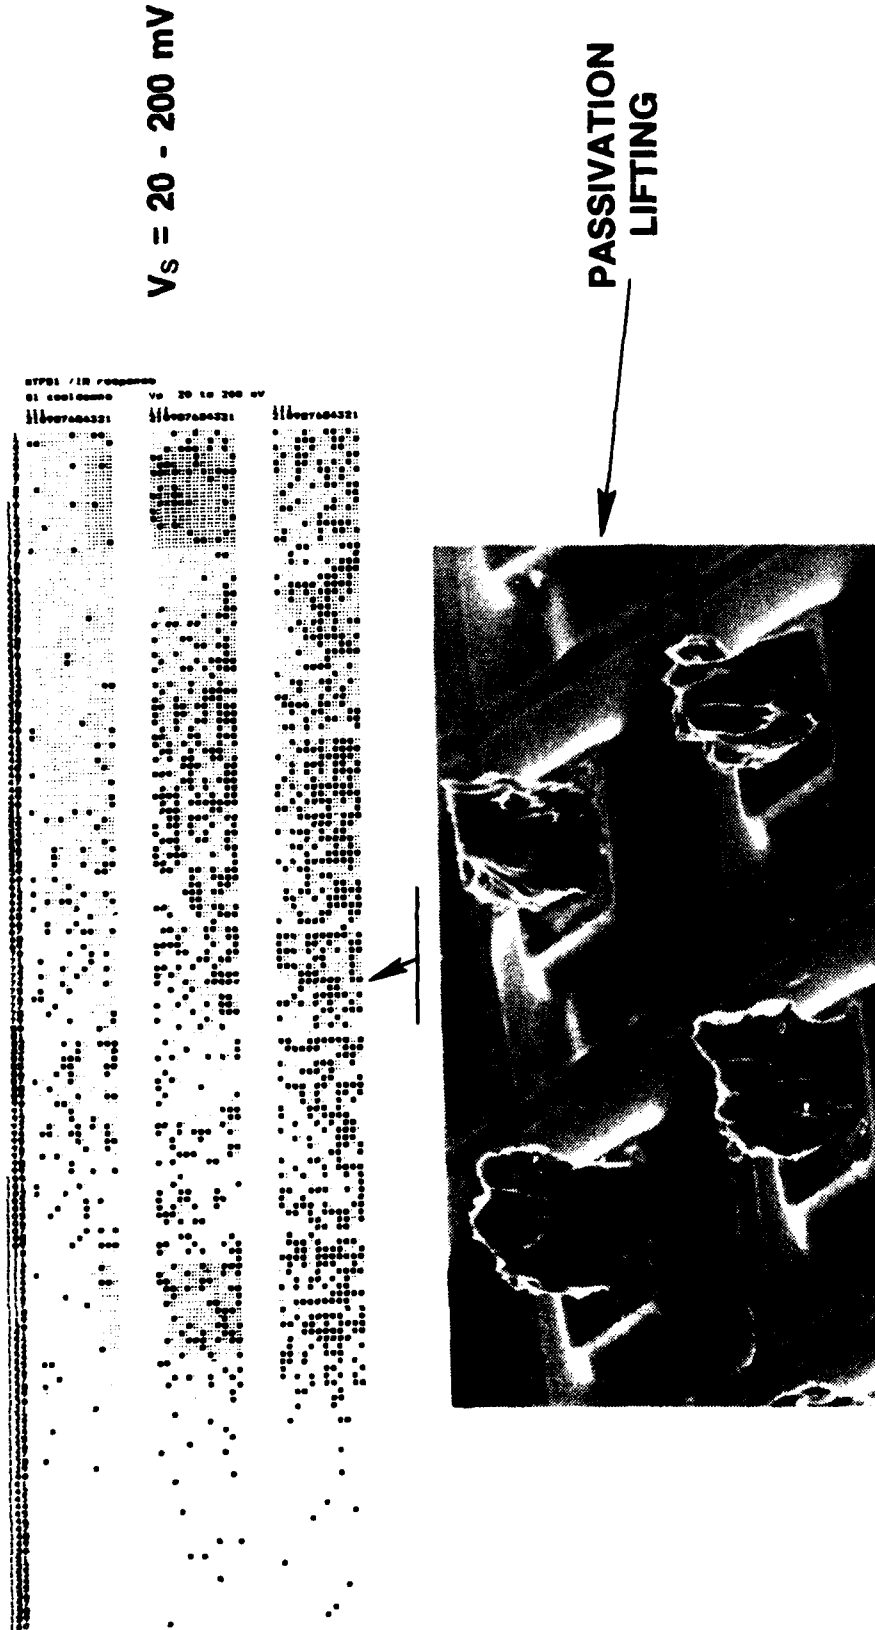
Figure 2-8a shows the gray scale map of device operability of the 160×3 (12) LWIR HgCdTe hybrid array (Assembly 5089) after 81 cumulative thermal cycles and Figure 2-8b shows an SEM micrograph of several pixels on the array which showed poor IR response. Figure 2-8b shows that the SiO_2 passivation layer is lifting from the surface and is thus ineffective in passivating the array surface and results in poor uniformity of operability across the array. This again was probably due to surface contamination prior to the passivation step and is not an inherent process limitation.

Figure 2-8. (a) Gray-scale Map Showing Detector IR Response Uniformity after 81 Cumulative Thermal Cycles (Assembly 5089). (b) SEM Micrograph of Pixels (after pulling apart hybrid) Showing Poor IR Response Due to Passivation Layer Delamination.

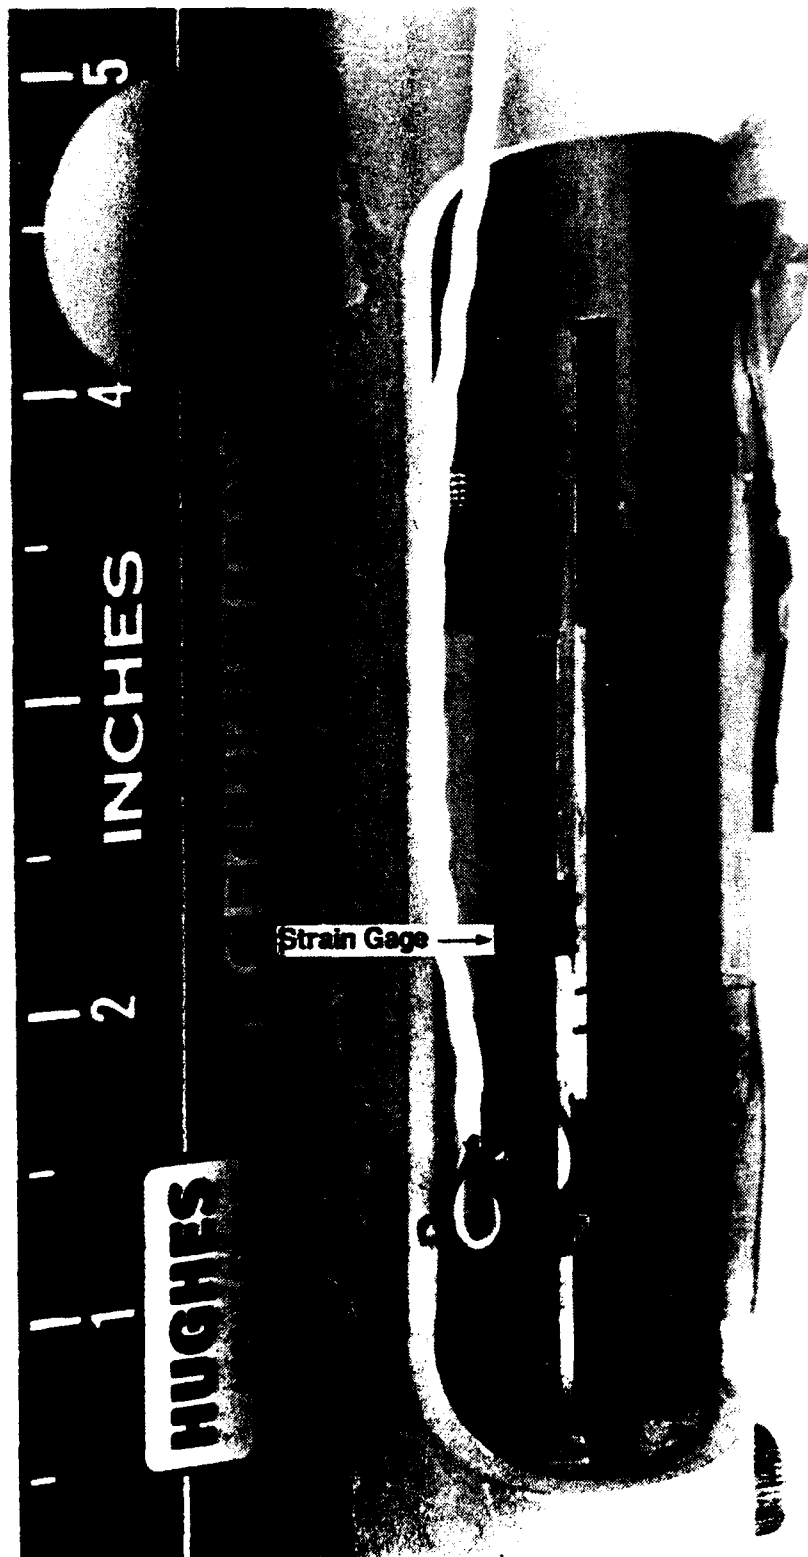
Figure 3-2. Close-up of Test Specimen in Holding Fixture

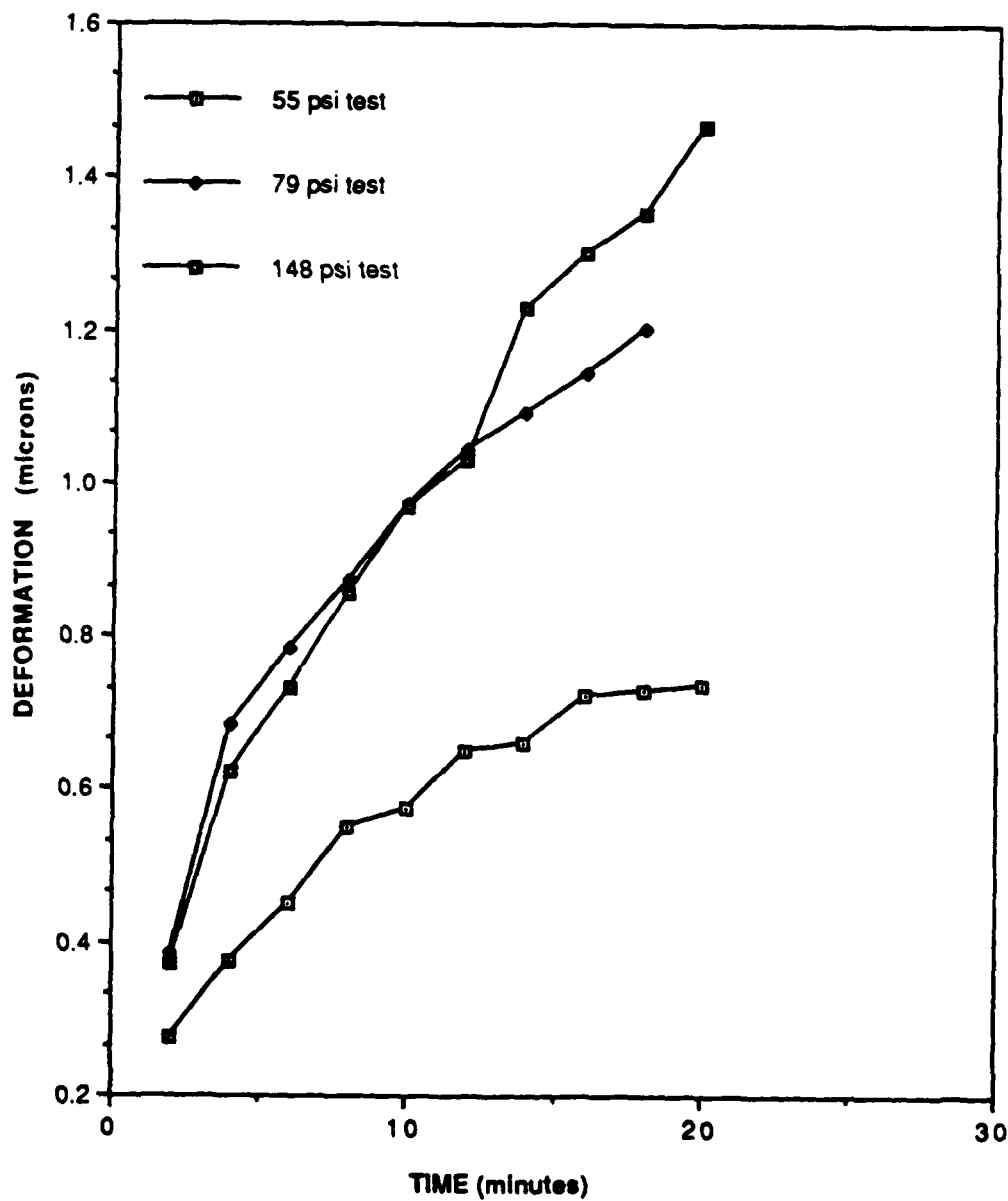
Figure 3-3. Room-temperature Creep Tests at 294K

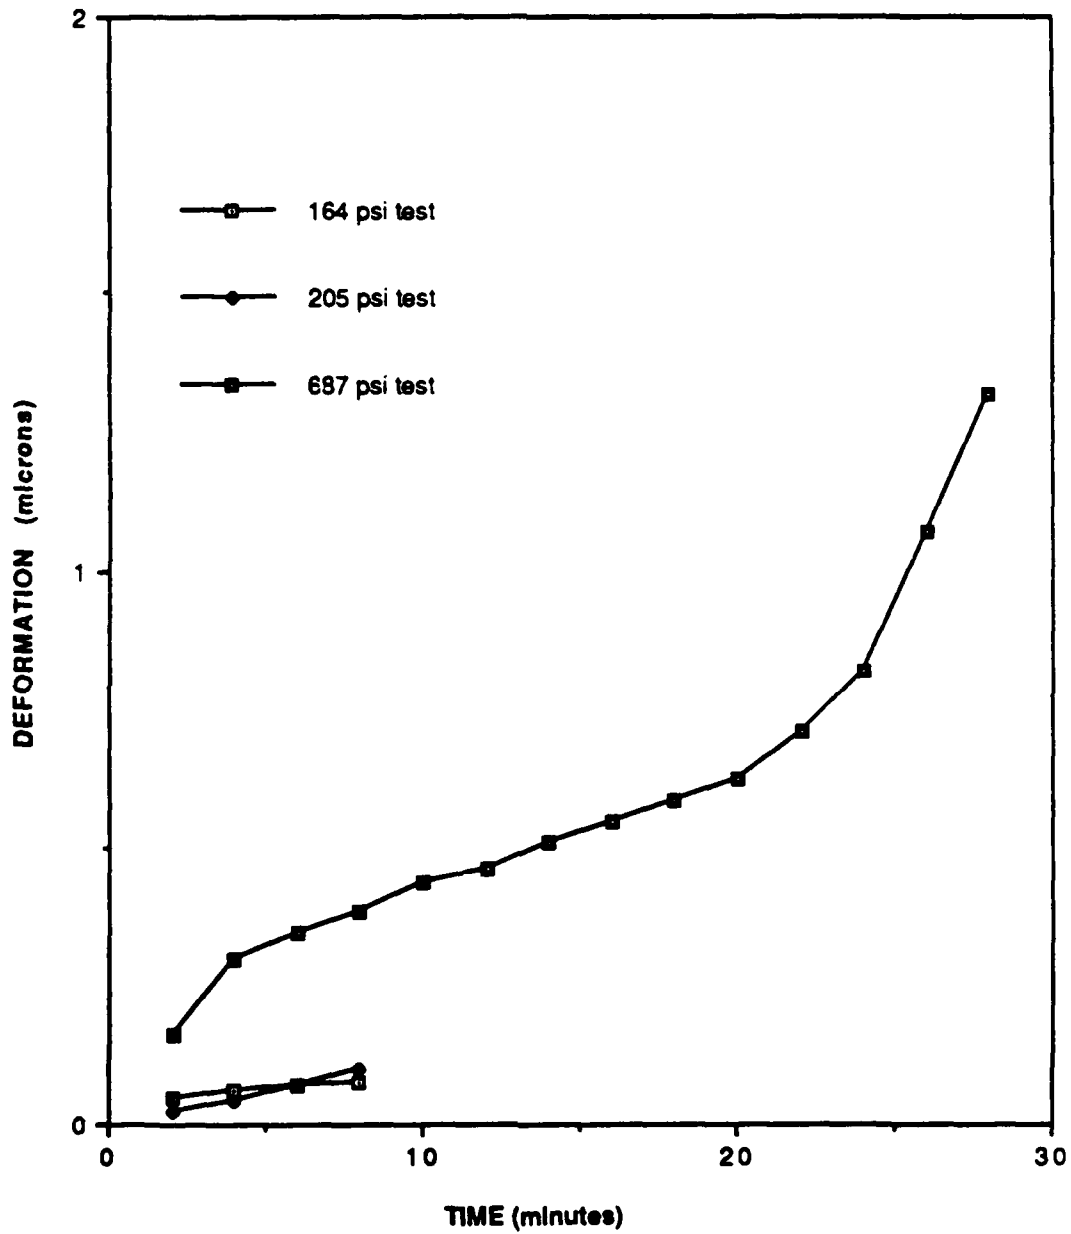
The creep characteristics of the specimen tested in dry ice and acetone are shown in Figure 3-4, and actual values are recorded in Table 3-2. The specimen held at 164 psi was first deformed a total of $3.1\text{ }\mu\text{m}$ at a constant rate of $0.6\text{ }\mu\text{m/min}$. The specimen held at 205 psi was first deformed $5.0\text{ }\mu\text{m}$ at a rate of $0.9\text{ }\mu\text{m/min}$. These specimens were held at constant load for 8 minutes when the test had to be terminated due to strain gage failure. The specimen held at 687 psi was deformed $7.5\text{ }\mu\text{m}$ at a constant rate of $1.2\text{ }\mu\text{m/min}$ and held at constant stress for 20 minutes. The curve beyond 20 minutes represents the deformation that occurred as the stress was cycled from 671 psi to 703 psi for 4 cycles. Creep rate is seen to increase with increasing constant stress for the three tests. The portion of the 687 psi test from 20 to 28 minutes indicates that large deformations resulted from ± 16 psi changes in the constant stress level, and do not represent normal creep behavior.

Figure 3-4. Dry -ice and Acetone Creep Tests at 189K

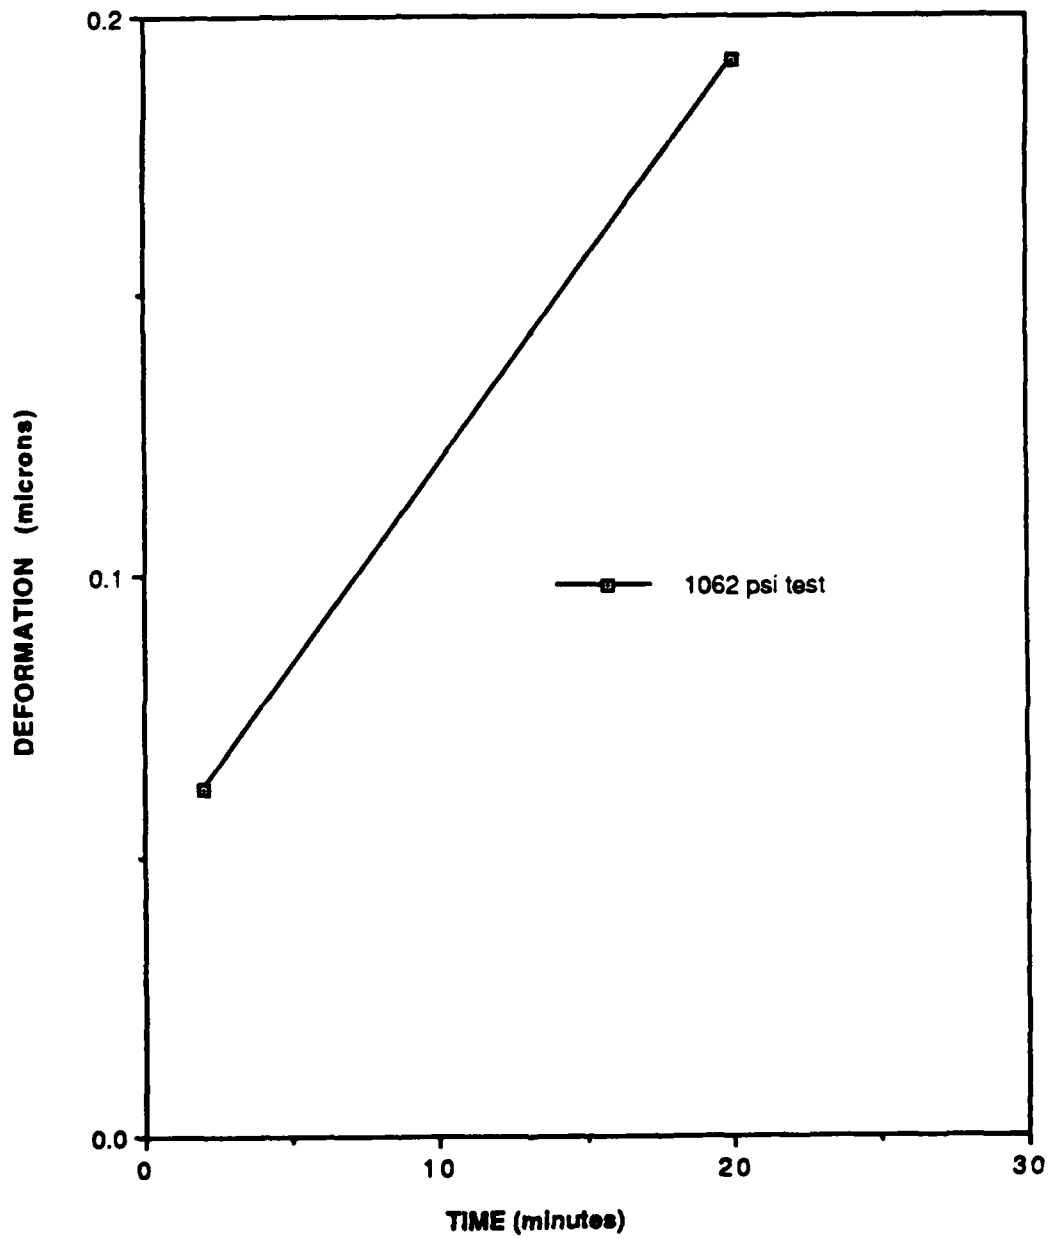
Figure 3-5. Liquid-nitrogen Creep Tests at 77K

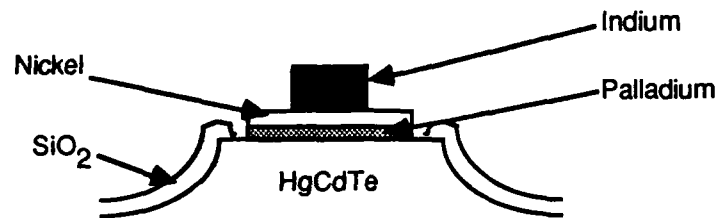
The next step was to strip 128² devices of their layers (metal and SiO₂) so that defect etching could be performed. The architecture of devices, with a description of the thin film layers, is shown in Figure 4-1. Stripping occurred in three steps:

Figure 4-1. Architecture Layers of Diode

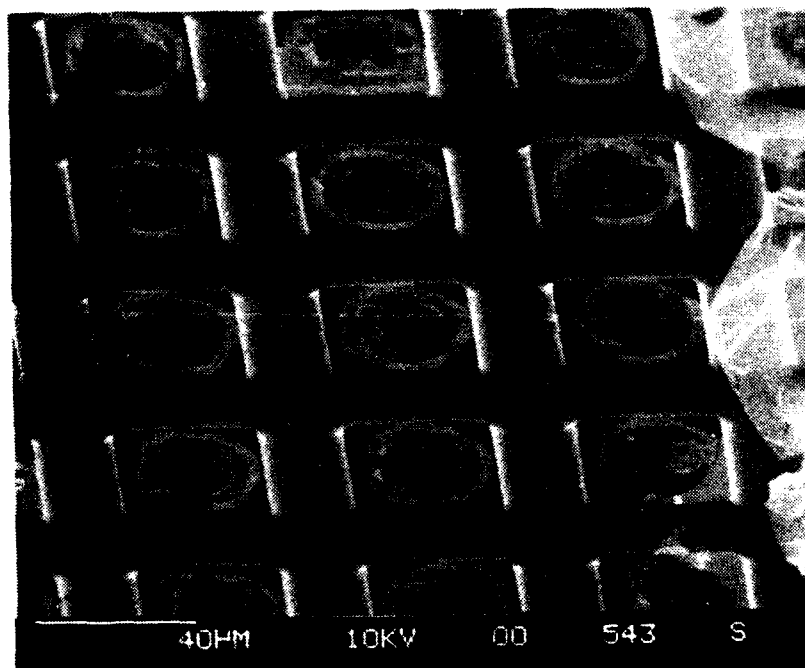
Large fissure-like cracks were seen on assembly 6509 (200 thermal cycles) before the dislocation etch, as shown in Figure 4-2. This suggests damage induced by hybridization or thermal cycling, but will need verification with a larger number of samples. It is also possible that the cracks were induced during tensile force testing.

Figure 4-2. Cracks Appeared in Assembly 6509 Even Before Dislocation Etch (Post Pd etch, no SiO₂)

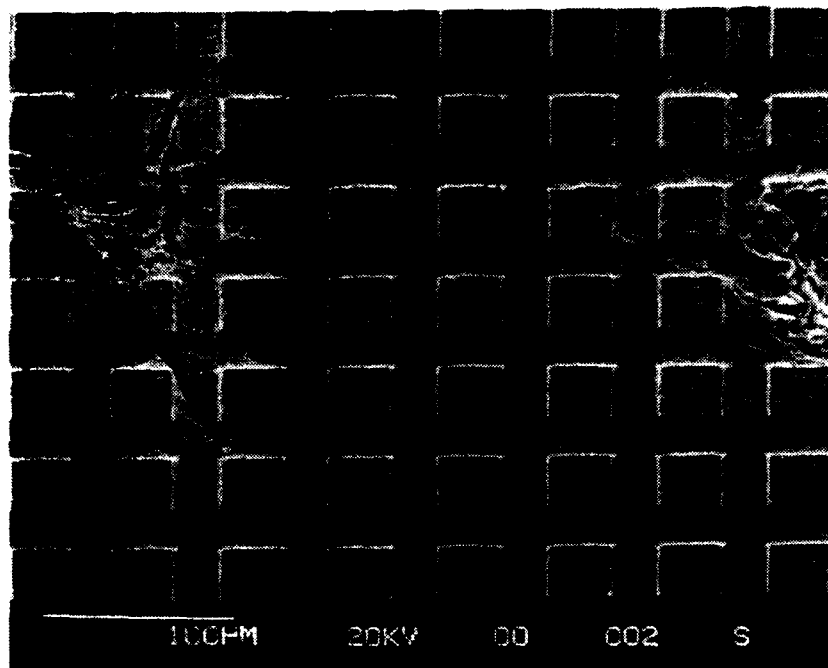
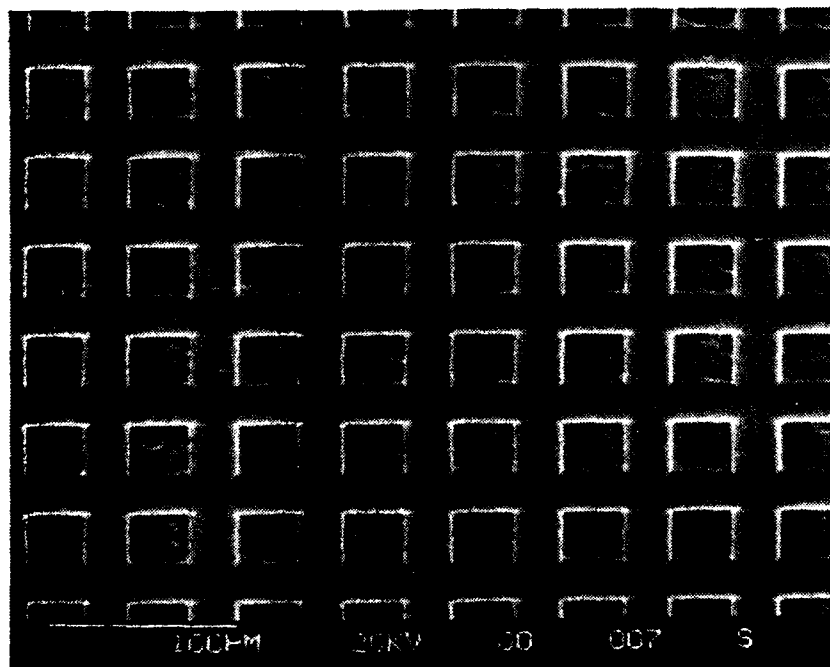
Electrical testing revealed that performance of diodes near induced damage was significantly lower than for remote diodes. The 11 numbered diodes shown in Figure 5-1 were among those diodes accessed electrically through the fanout, to which the array was hybridized. The I-V curves of the nine numbered diodes shown in Figure 5-1a are plotted in Figure 5-2a. The two numbered diodes pictured in Figure 5-1b and seven additional diodes from areas isolated from induced damage have their I-V curves plotted in Figure 5-2b.

Figure 5-1. Increased Etch-pit Density near Induced Damage. The dramatic increased in the density of revealed dislocations can be seen by comparing the densities near and remote from damage.

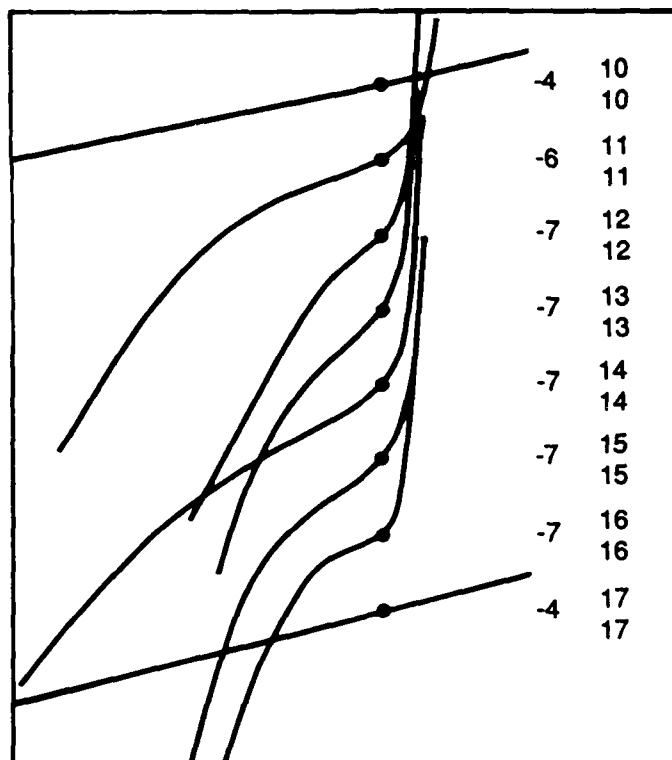
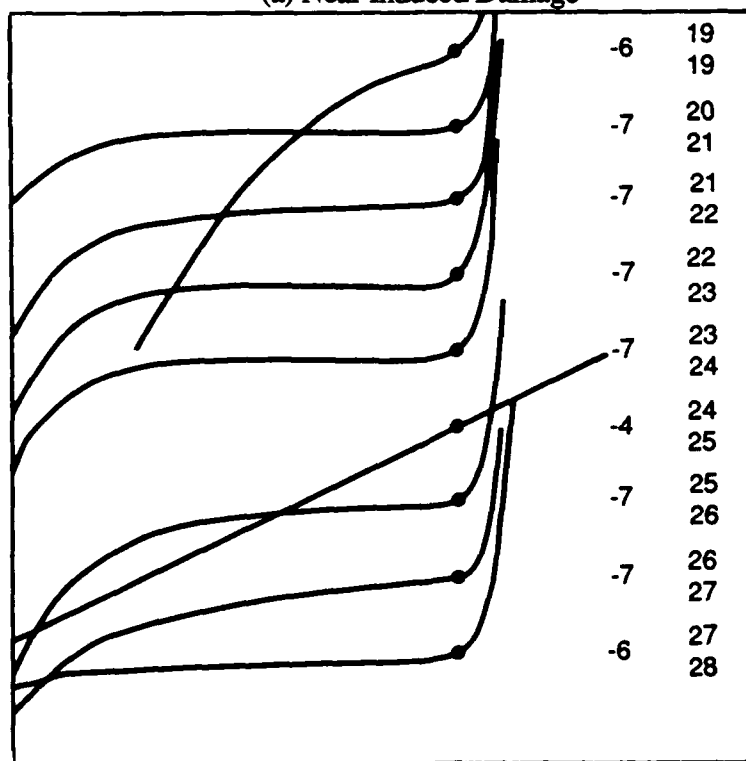
The degradation in I-V characteristics of diodes near points of induced damage can be seen by comparing the curves in Figure 5-2a to those in Figure 5-2b. Two quantities that decrease with degraded electrical performance are R_0 , the resistance at zero voltage, and R_T at -50 mV. Decreased R_0 of the damaged diode is seen as an increased I-V curve slope at the origin and decreased R_T can be seen as increased slope at -50 mV. One additional visual indication of reduced performance is reverse bias breakdown of the curves plotted in Figure 5-2a. The two linear I-V curves, diodes 10 and 17, indicate shorts. From Figure 5-1a it shows that diode 10

Figure 5-2. Degraded Electrical Performance near Manually Induced Damage. Degradation of electrical performance of diodes near induced damage can be seen as increased slope at 0 mV and -50 mV when compared to diodes remote from damage.

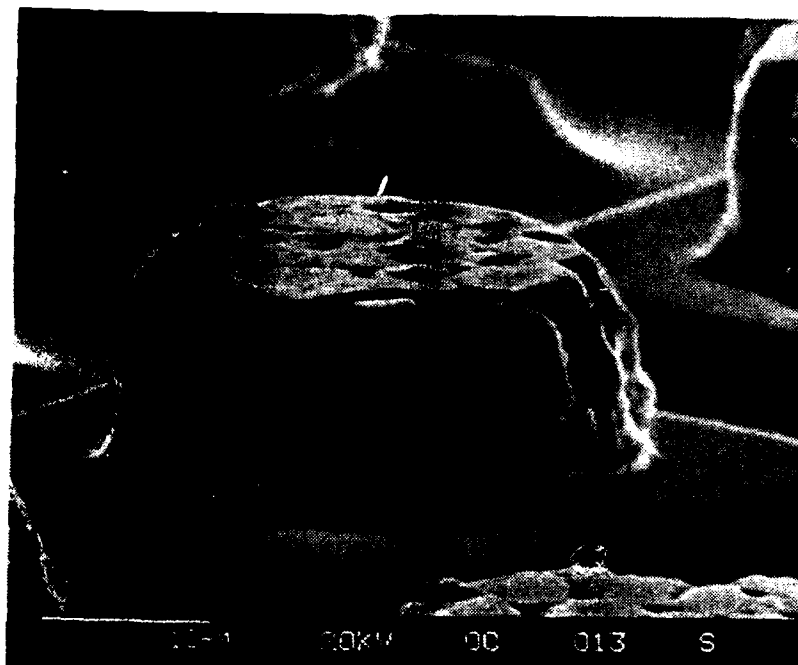
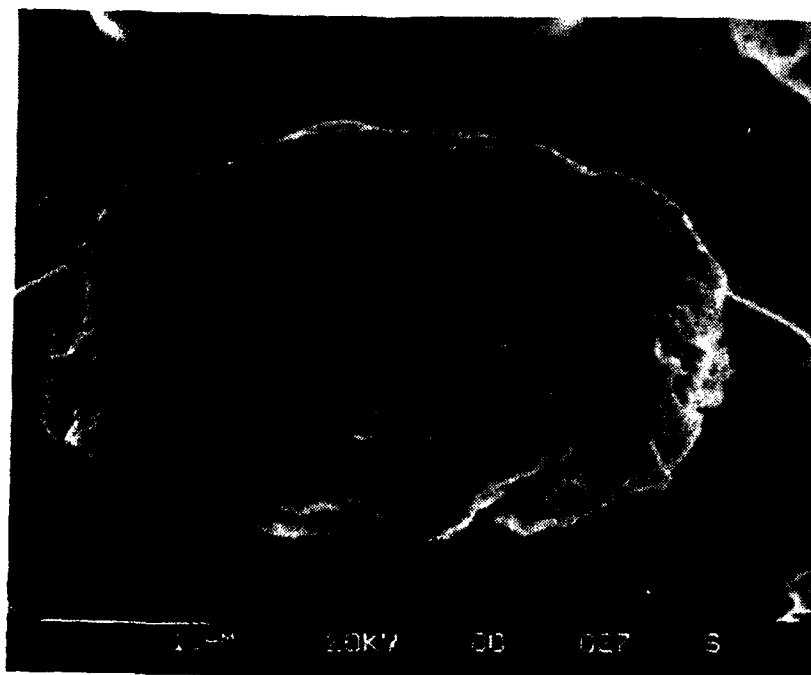
Figure 5-3. Hybridization Stress Buffered by Cold Flow Characteristics at Indium Bumps. Stress Calculated by dividing applied force by resulting cross-sectional indium area does not increased with increased hybridization force.

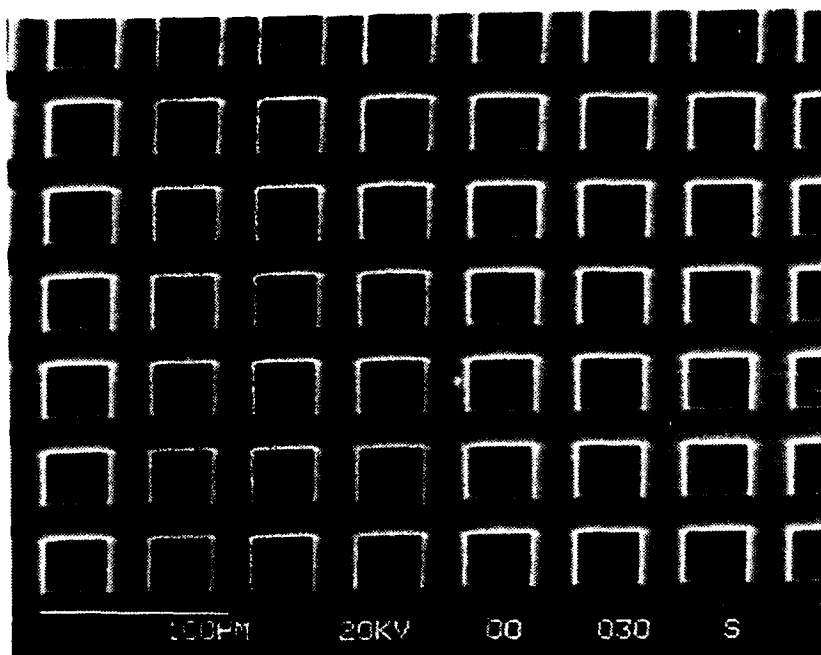
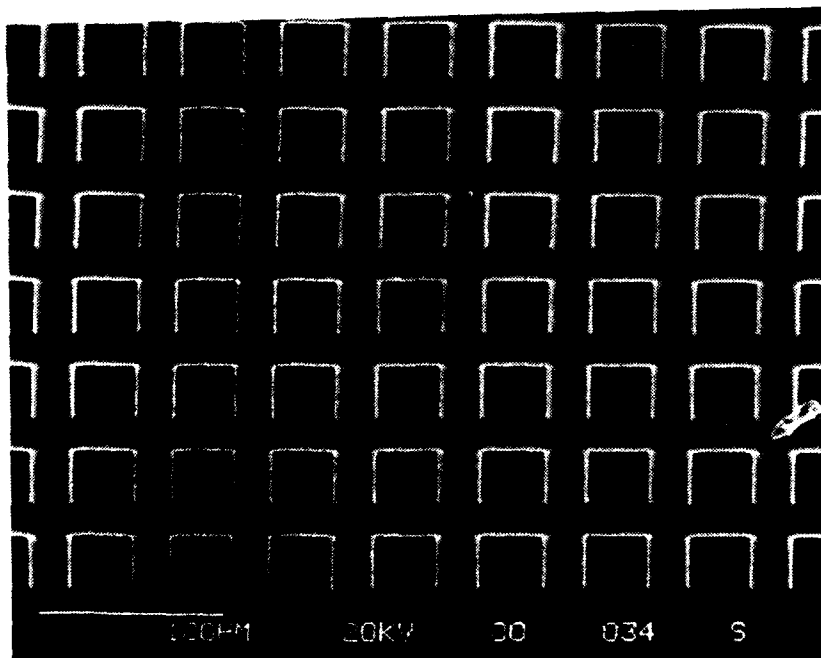
SEM analysis of the Task 2 IRFPAs revealed that increased etch pit densities occurred only where hybridization forces equal to or larger than 120 lb were applied. Etch pit densities typical of the arrays hybridized at pressures ranging 0.0 lb (unhybridized arrays) to 35 lb are presented in Figure 5-4. These arrays were hybridized at 8.4 lb (Figure 5-4a) and 35.1 lb, (Figure 5-4b) and the etch pit were densities found to be statistically equal to that of arrays that were not hybridized. The etch pit densities of the arrays pictured in Figure 5-4 as well as the remainder of Task 2 arrays hybridized with pressures up to 35 lb are compiled in Table 5-3. The tabulated results show that there is no change in etch pit density with increased pressure which corresponds well with the independence of stress and hybridization force discussed above.

Figure 5-4. Etch-pit Density Not Increased by Hybridization Forces between 0 and 120 lb. It can be seen that the density of revealed dislocations is unaffected by a four fold increase in hybridization force.

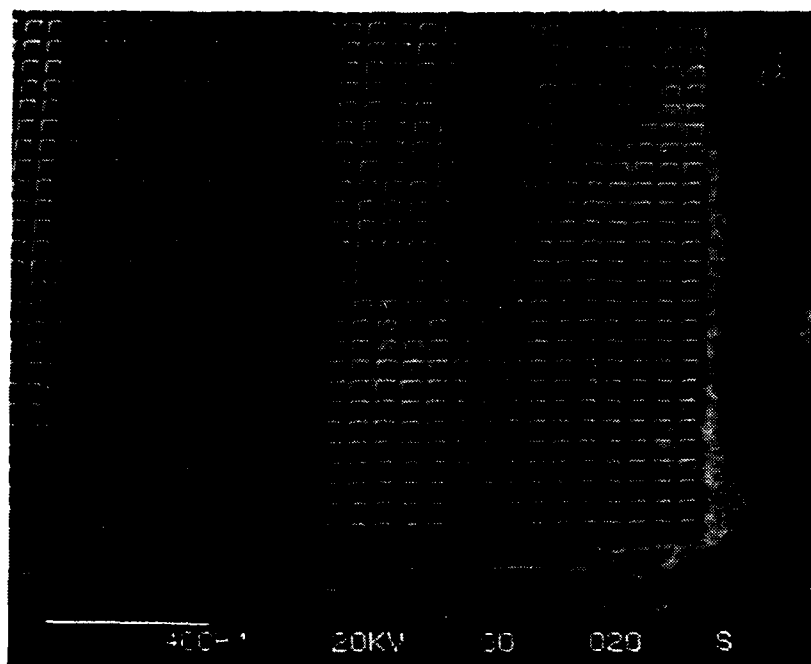
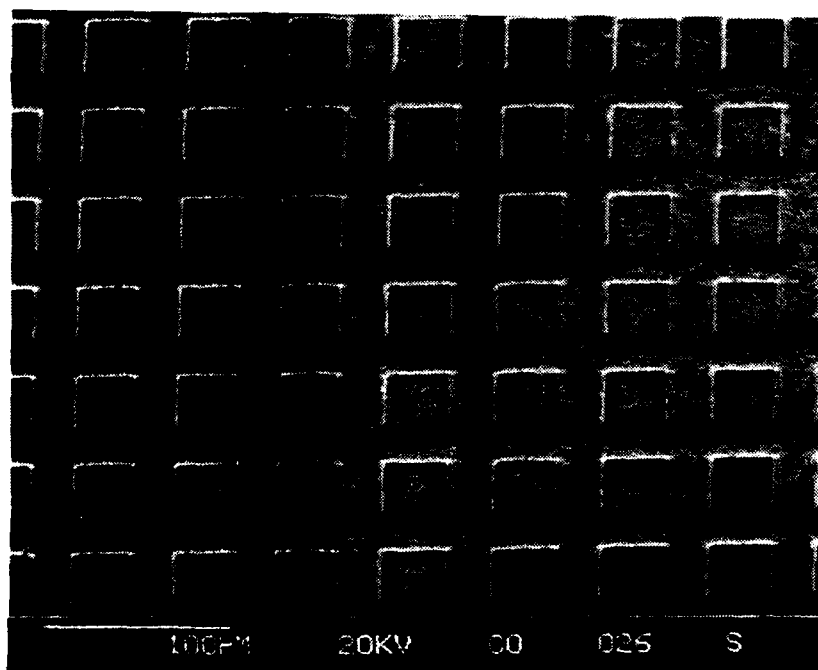
Figure 5-6. Increased Etch-pit Density Due to Hybridization a Force in Excess of 120 lb. A dramatic increase in the density at revealed dislocation can be seen to the right of the "line" of demarcation.

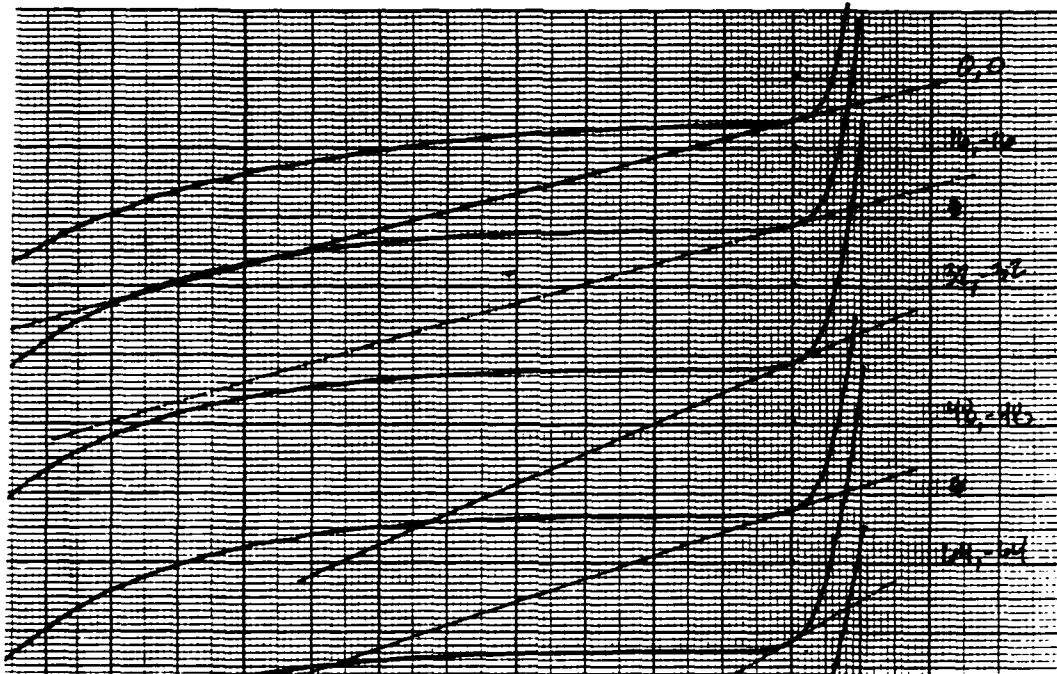
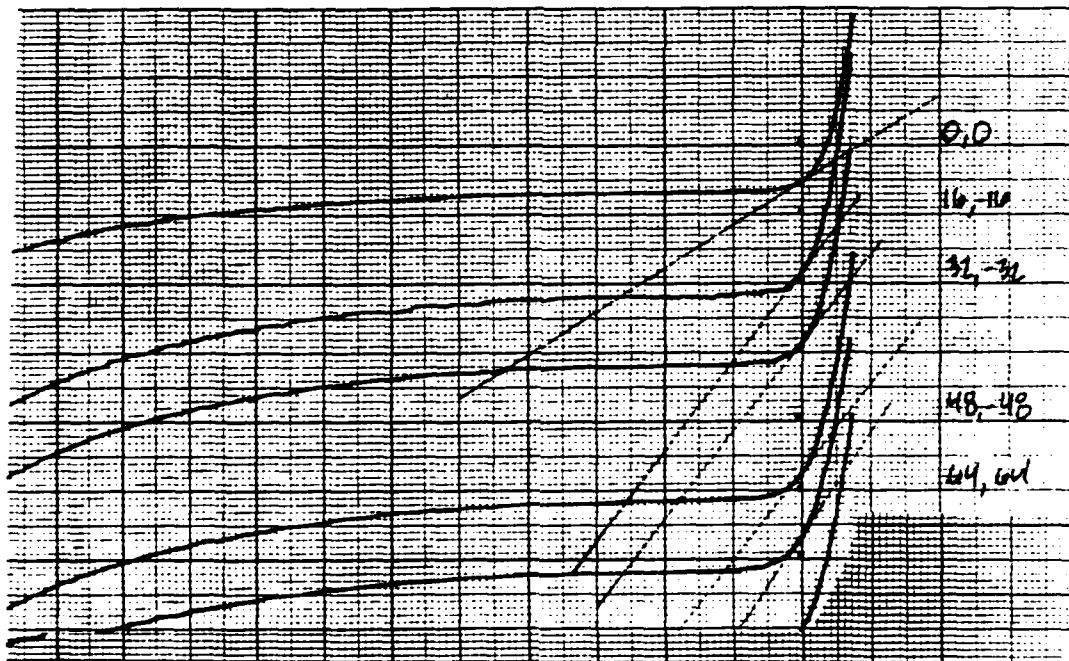
I-V curves of several diodes from a Task 2 array hybridized at 34 lb are shown in Figure 5-7. The pictured array and several others were tested using open-dish probing. The I-V curves in Figure 5-7a were measured before hybridization and those in Figure 5-7b were generated after hybridization. A comparison of the two sets of I-V curves show that the I-V characteristics of the tested diodes are unchanged by hybridization. Indications of degradation such as early reverse bias breakdown or a change in slope at zero bias, R_0 , do not occur. The only consistent changes that occur is a shifting of the curves along both the current and voltage axis. These shifts

Figure 5-7. Open-field-of-view Electrical Performance Unchanged by Hybridization at 35 lb. I-V curves typical of arrays viewing warm scene show no degradation due to hybridization.
